Laura M. Fayad  
Ihab R. Kamel  
Satomi Kawamoto  
David A. Bluemke  
Frank J. Frassica  
Elliot K. Fishman

## Distinguishing stress fractures from pathologic fractures: a multimodality approach

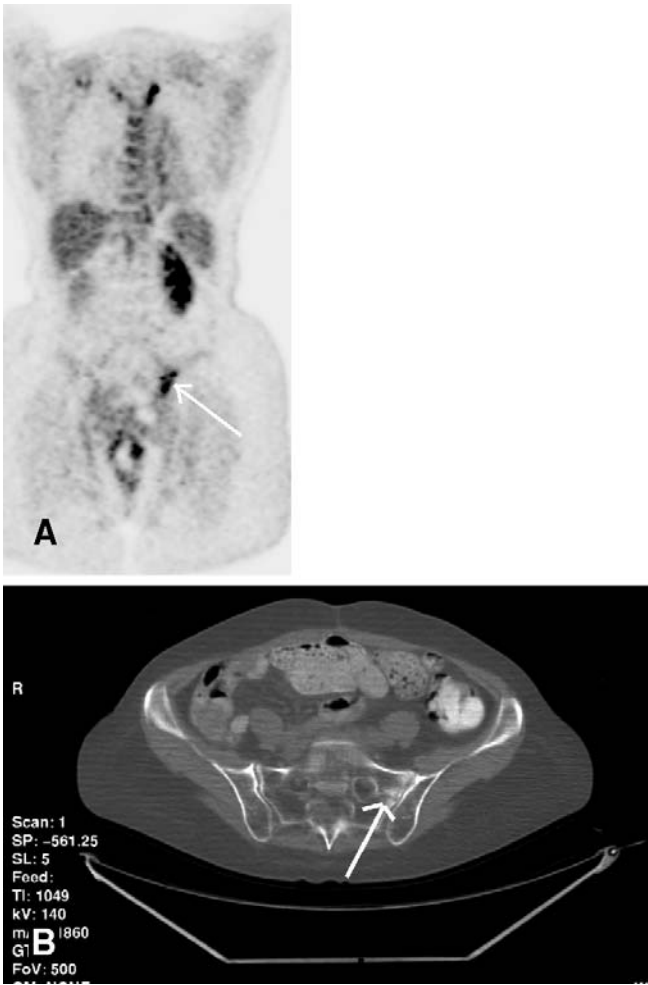
**Fig. 6A, B** A 73-year-old woman with a history of adenocarcinoma of the rectum who underwent abdominal perineal resection with adjuvant chemotherapy and radiation treatment. Imaging was performed for the evaluation of metastatic disease. **A** PET scan, axial section, shows moderate linear FDG uptake in the left sacrum (*arrow*). **B** CT scan, axial image, shows a left sacral insufficiency fracture (*arrow*)

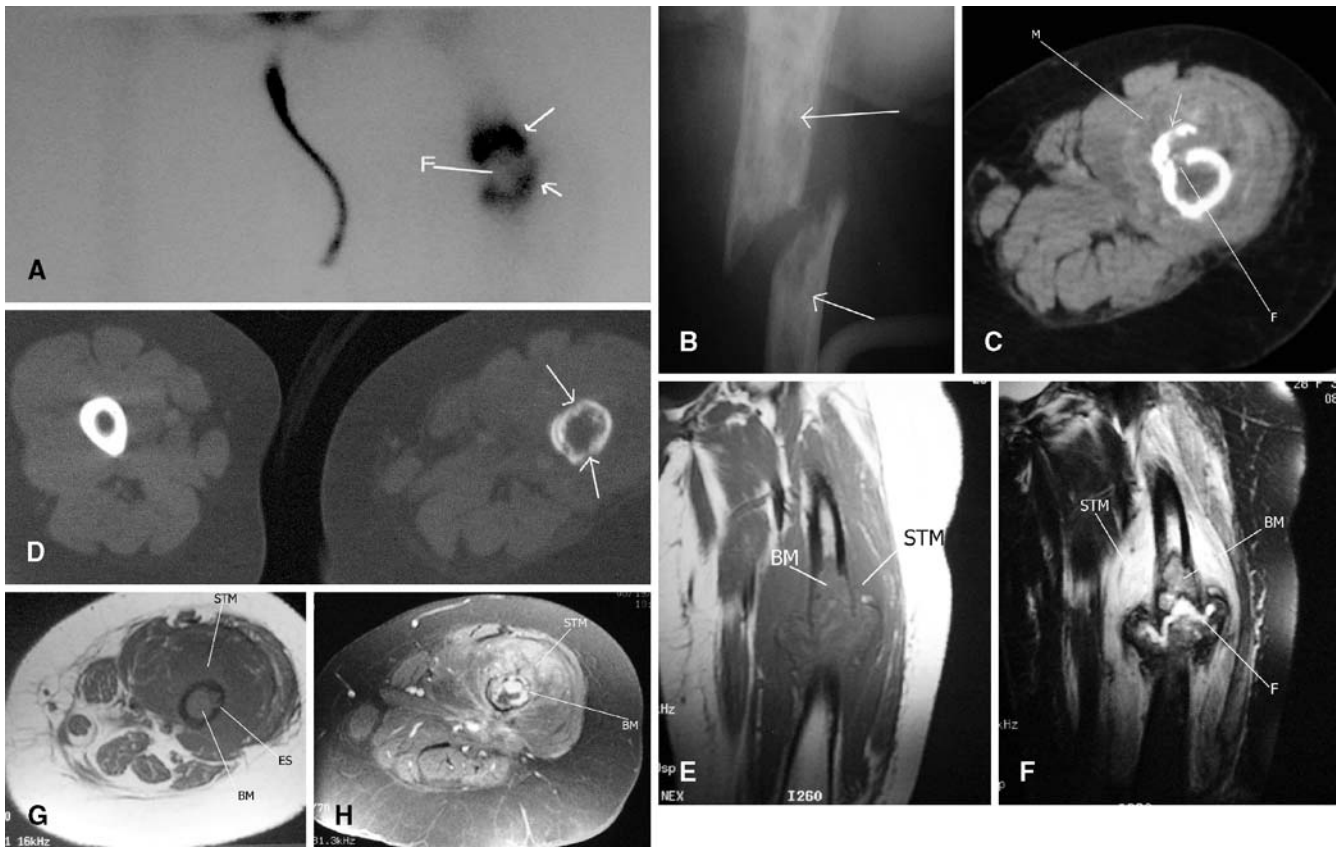
**Fig. 12A—H** A 28-year-old woman with a history of chronic knee pain. Radiographs and MR images of the knee revealed no significant abnormalities. The symptoms persisted and subsequent bone scan demonstrated nonspecific increased uptake along the mid-femoral diaphysis. CT and MR images of the femur are shown. Biopsy revealed malignant fibrous histiocytoma. **A** Bone scan reveals increased uptake in the femur (*arrows*) around a linear photopenic area (*F*). **B** Radiograph of the femur shows a pathologic fracture. A permeative pattern of destruction is present (*arrows*). **C** Axial contrast-enhanced CT image at the level of the fracture (*F*) shows a soft tissue mass (*M*) and cortical destruction (*arrow*). **D** Axial contrast-enhanced CT image superior to the level of the fracture shows the cortical destruction in more detail (*arrows*). **E**

Coronal T1-weighted MR image (SE; TR 400, TE 14) shows a well-defined bone marrow signal abnormality (*BM*) representing the underlying mass in the femur and surrounding soft tissue mass (*STM*). **F** Coronal T2-weighted MR image (FSE; TR 5000, TE 90) shows the fracture line (*F*) to best advantage with the surrounding bone marrow (*BM*) and soft tissue mass (*STM*). **G** Axial T1-weighted MR image (SE; TR 400, TE 14) again shows decreased signal in the bone marrow (*BM*), endosteal scalloping (*ES*) and the soft tissue mass (*STM*). **H** Axial contrast-enhanced T1-weighted MR image (FSPGR; TR 220, TE 4.2, flip angle 70°) shows nodular enhancement of the mass within the bone marrow (*BM*) as well as enhancement of the soft tissue component (*STM*)
